Preventive Conservation in Historic Houses and Palace Museums: Assessment Methodologies and Applications

Conference Proceedings

Preventive Strategies for Neuschwanstein Castle

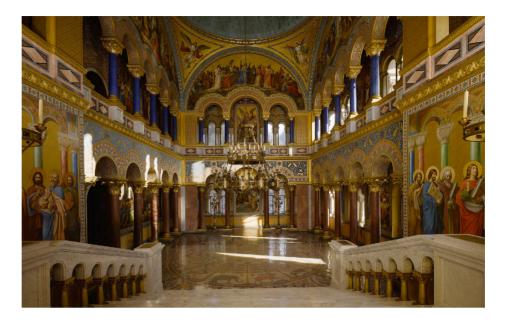
Neuschwanstein Castle,
Singers Hall, southern
oriel. Vis- and UV-picture
of the wall painting. In
visible lights salt damages,
flaking and already lost
paint layer are the obvious
damages. The different UVfluorescence shows various
phases of local retouches
and repairs. (© Bayerische
Schlösserverwaltung, Armin
Schmickl)

The climate indicated damages originate from a very high humidity. Condensation problems on the glazing and the outer walls were obvious, mould, salt damages and tracks of liquid water on wall paintings are common (fig. 2). Most of the fabrics on display show heavy light damages, from deterioration of colour to a complete loss of filament stability (fig. 4). Efforts to establish a better light-protection failed, because the need for fresh air for the visitors led to constantly open windows and therefore to direct sunlight exposure. Visitors produce a high amount of dust; textile fibres, skin flakes, hair and dirt trickle off people and sediment on the surfaces. Every dusting cycle "sands" the surfaces and leads to a loss of original substance. Most of the gilded metal surfaces and the varnished oak panels and furniture have lost their original cover over the past decades. To give back some gloss to the surfaces they were improperly treated with different non-siccative oils which embedded the dust completely; dark and sticky, even "furry," surfaces are the consequence (fig. 3). For years the barrier situation along the visitor path was insufficient, erosion because of touching and even vandalism is the result (fig. 4).

obvious on the first sight; following detailed surveying and mapping of the damages especially on the wall paintings identified not only the existing damages but also not apparent local touch ups notably on the outer walls (fig. 2). The big amount of damages and losses of the paint layer shows that the condensation is really a high risk for the wall paintings.
