KEY FIGURES: EPICO AT THE PALACE OF MAINTENON, FRANCE

APRIL 2019

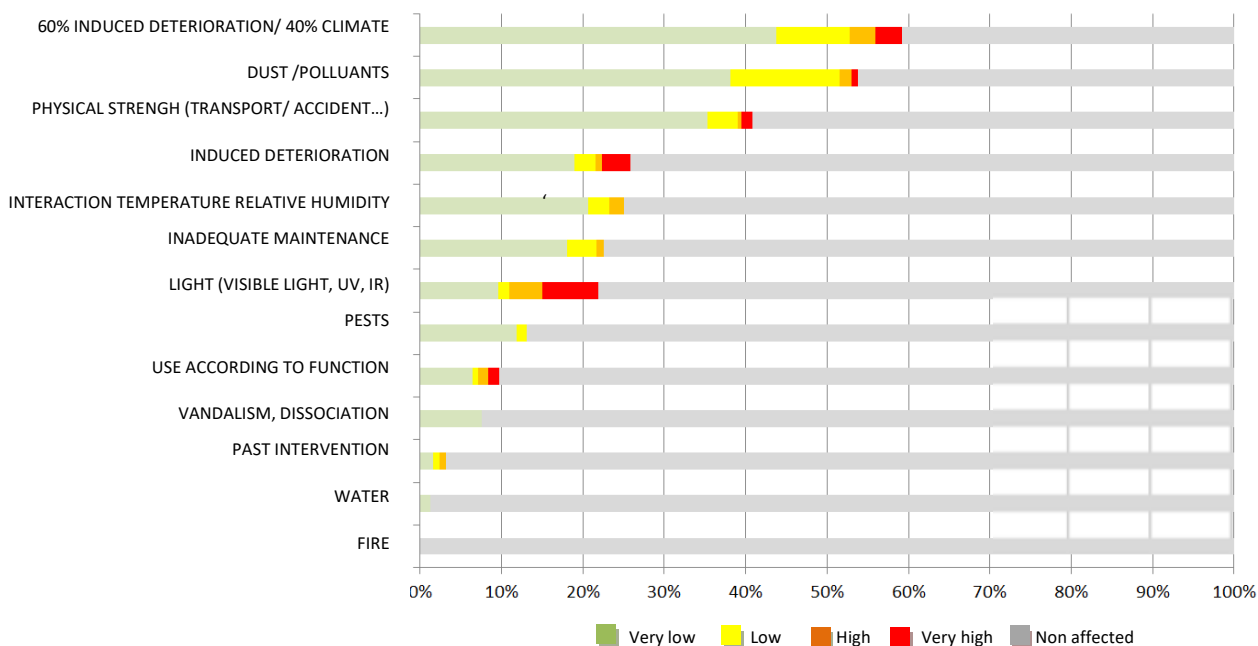
List of causes

RANKING: alteration cause impact (objects affected by causes + scale of damage):

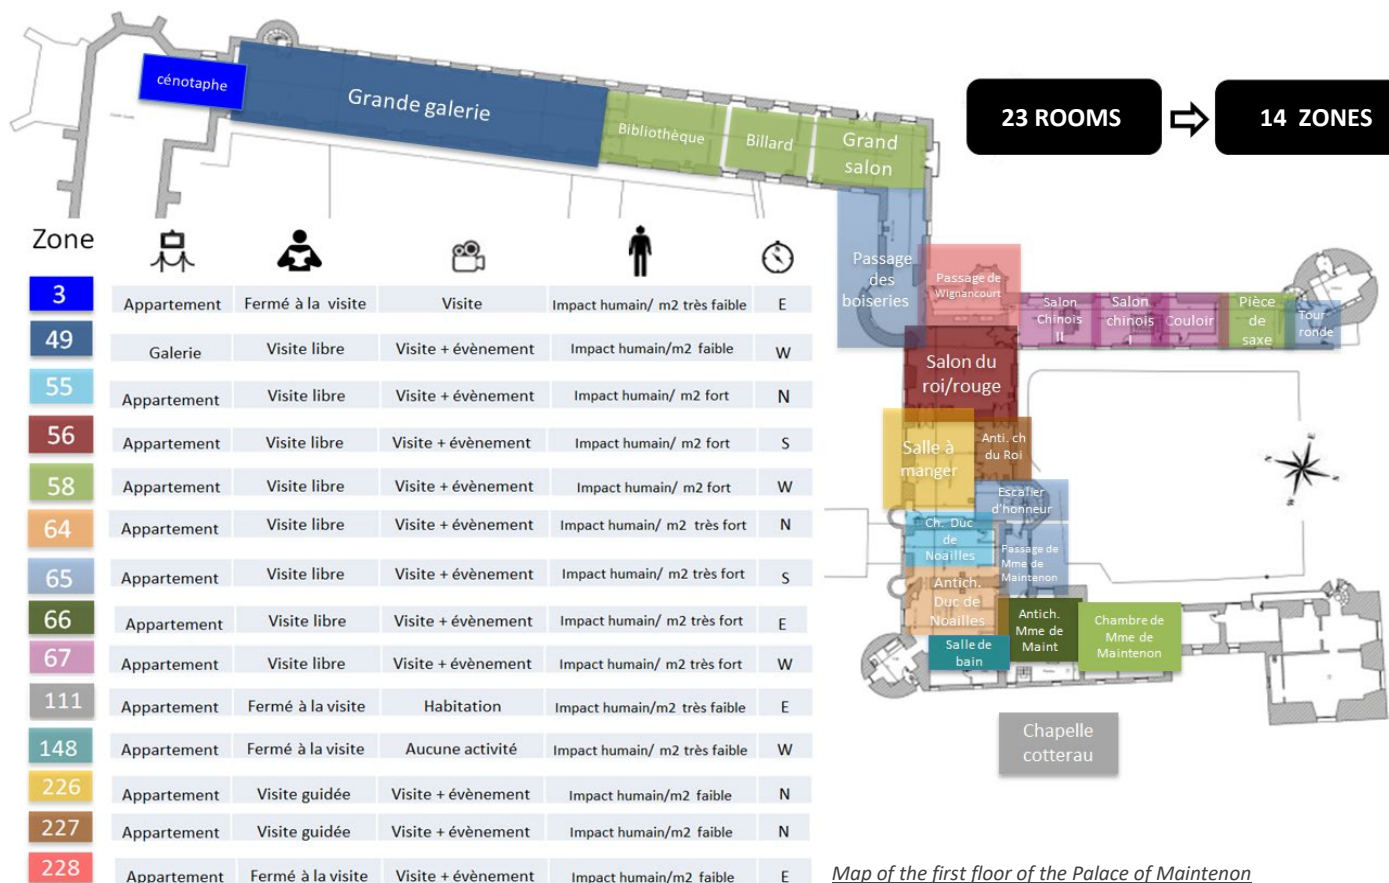
Map of the first floor of the Palace of Maintenon

Zoning makes it possible to group rooms with similar characteristics (museography, type of visit, activities (film shoots events...), human impact and orientation) with have similar impact on the collection.

*On the map we have the name of the room and the color of the zone
