KEY FIGURES: EPICO AT THE PALACE OF QUELUZ, PORTUGAL NOVEMBER 2019

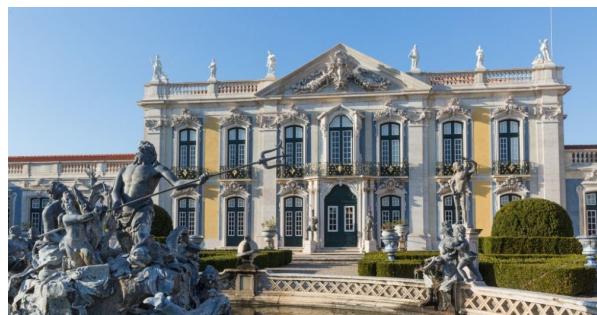
TYPOLOGY	NB ITEM IN THE SAMPLE
FOURNITURE	18
PAINTING	2
GRAPHIC ART	7
SCULPTURE	1
ART OBJECT	26
DECOR	9
Total	63

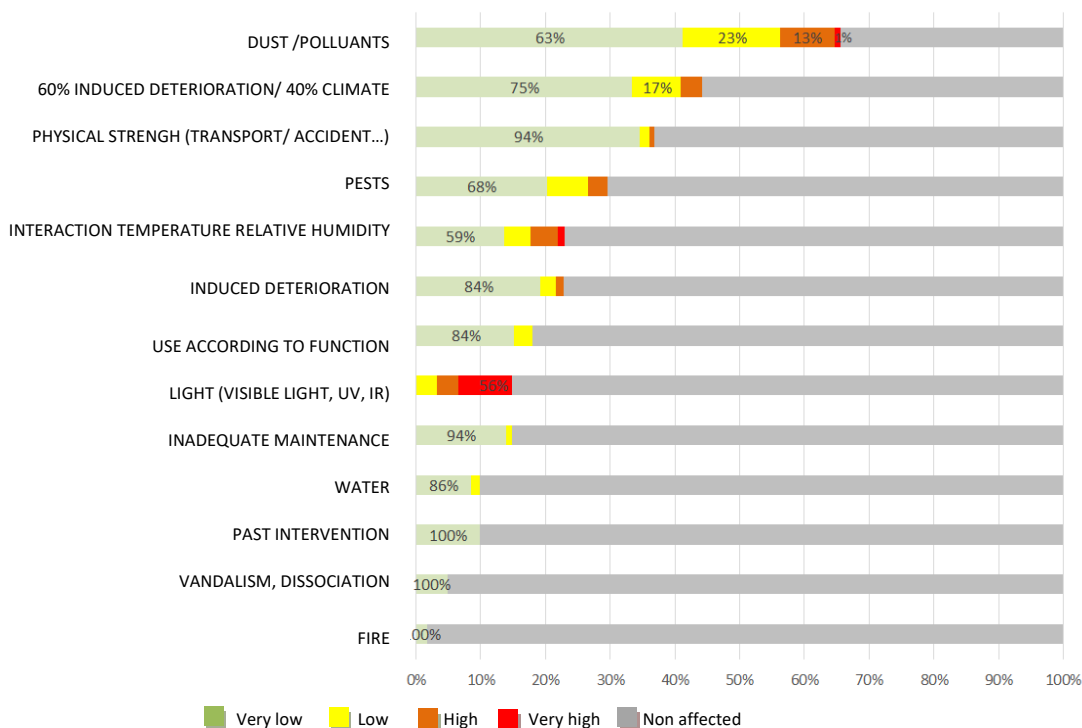
- **4 major causes identified:** Dust, Inherent degradation-climate, Physical forces, Pests

RANKING: alteration cause impact (objects affected by causes + scale of damage):

- **4 actions could improve** the conditions of conservation of 80% of the objects affected by the causes mentioned above.

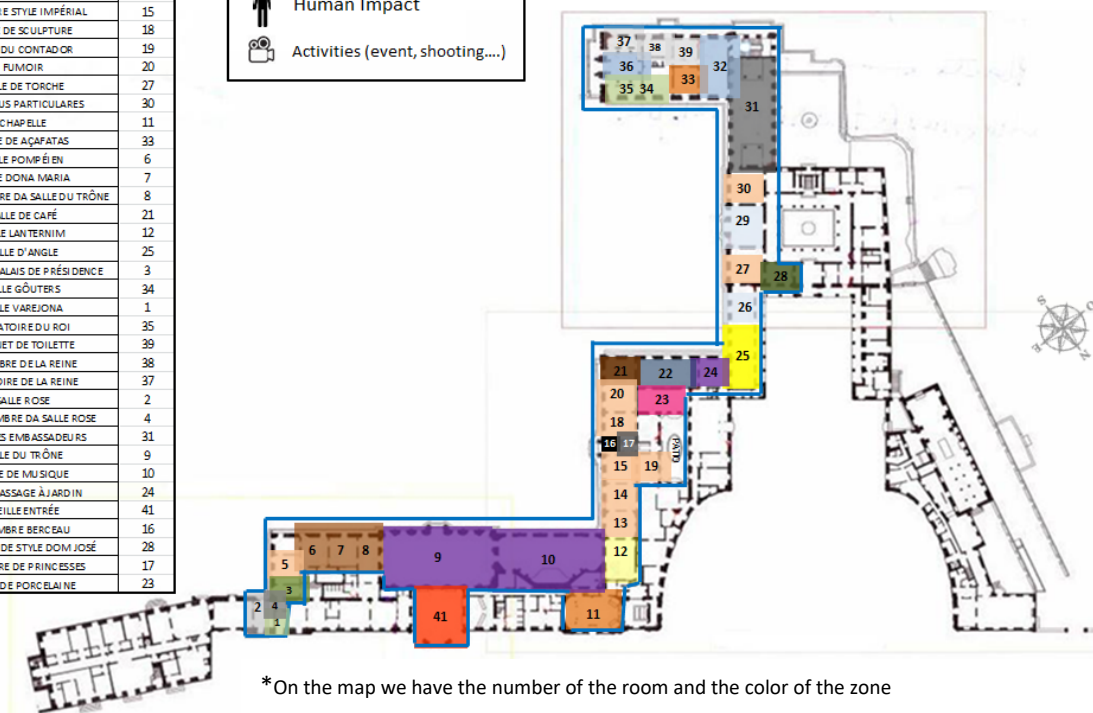
Zoning makes it possible to group rooms with similar characteristics (museography, type of visit, activities, human impact and orientation) where we could have similar impact on the collection.

41 ROOMS → 21 ZONES
