KEY FIGURES: EPICO AT THE PALACE OF MAINTENON, FRANCE

APRIL 2019

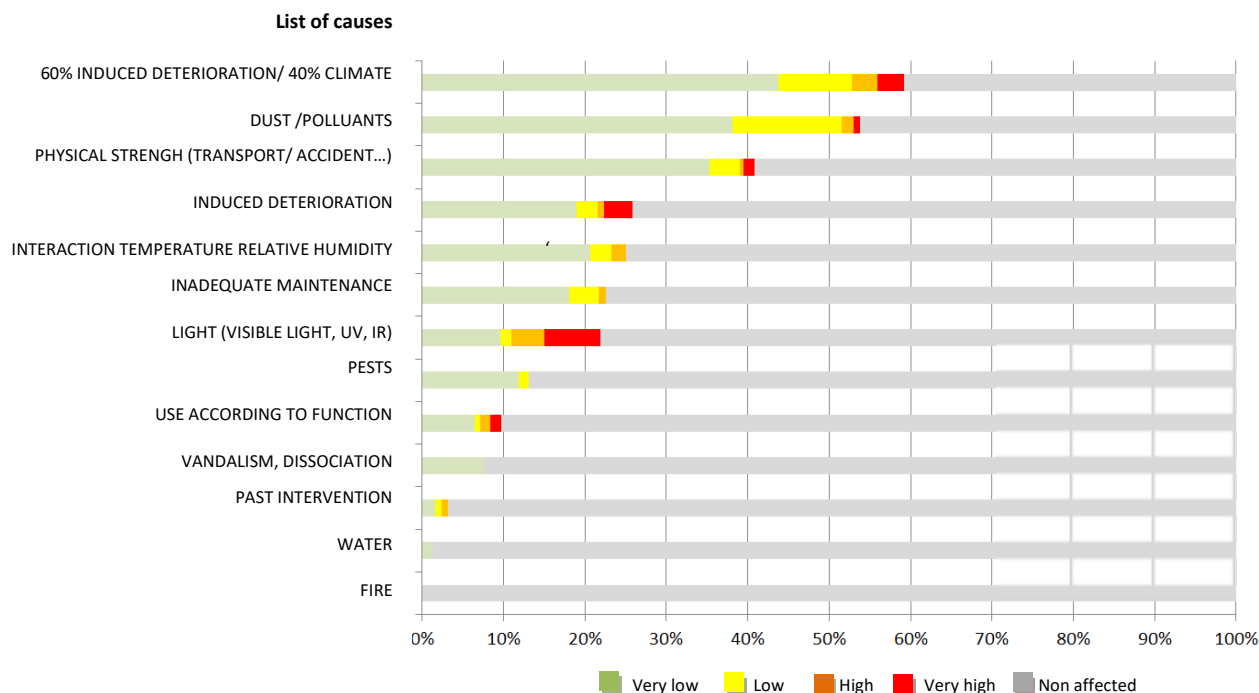
RANKING: alteration cause impact (objects affected by causes + scale of damage):

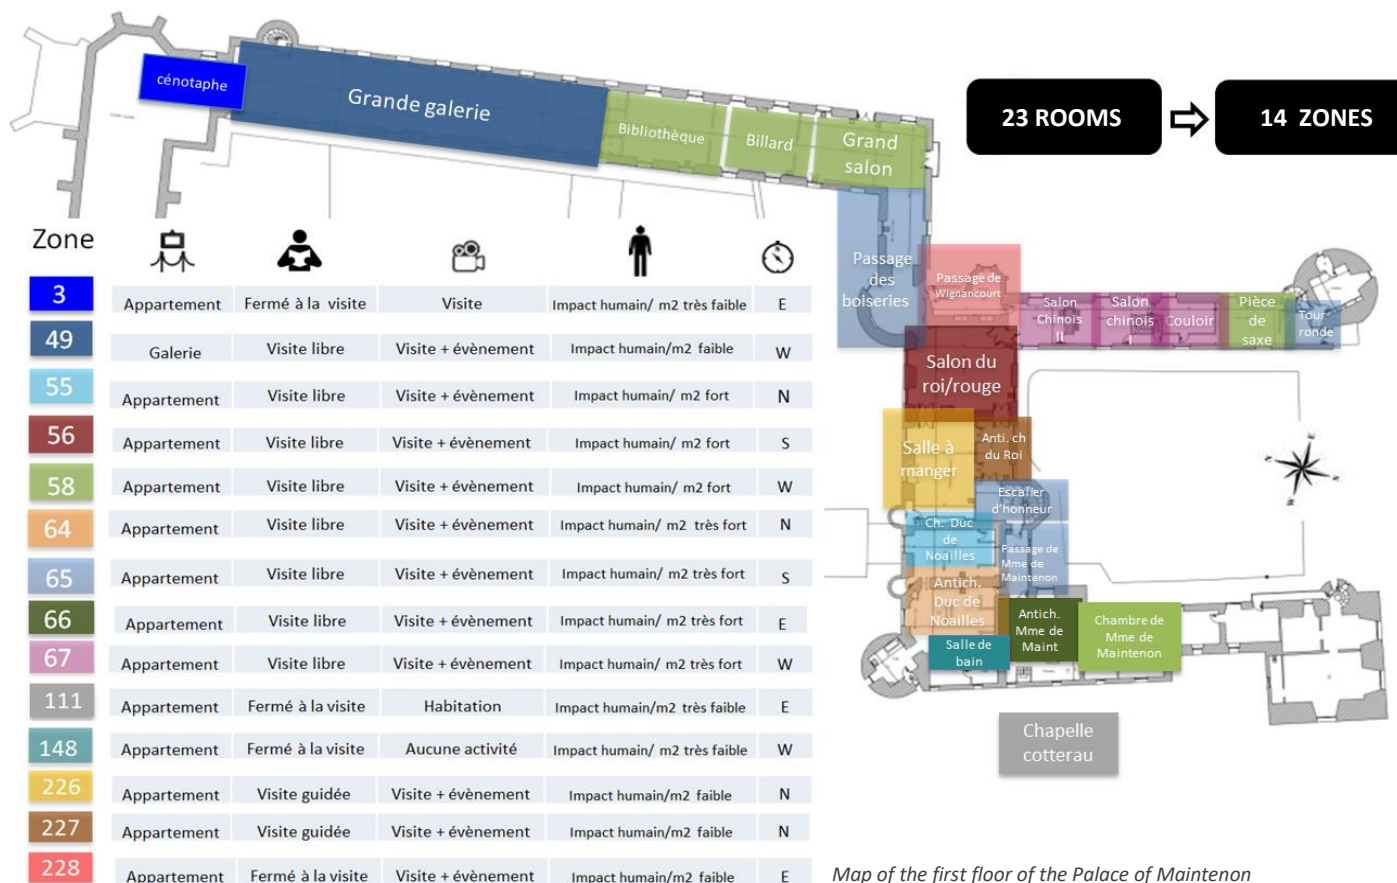
Map of the first floor of the Palace of Maintenon

Zoning makes it possible to group rooms with similar characteristics (museography, type of visit, activities (film shoots events...), human impact and orientation) with have similar impact on the collection.

*On the map we have the name of the room and the color of the zone
