Preventive
Conservation
in Historic Houses
and Palace
Museums:
Assessment
Methodologies
and Applications

Conference Proceedings

A Museum at Risk: Managing Indoor Climate Risks in Heeswijk Castle

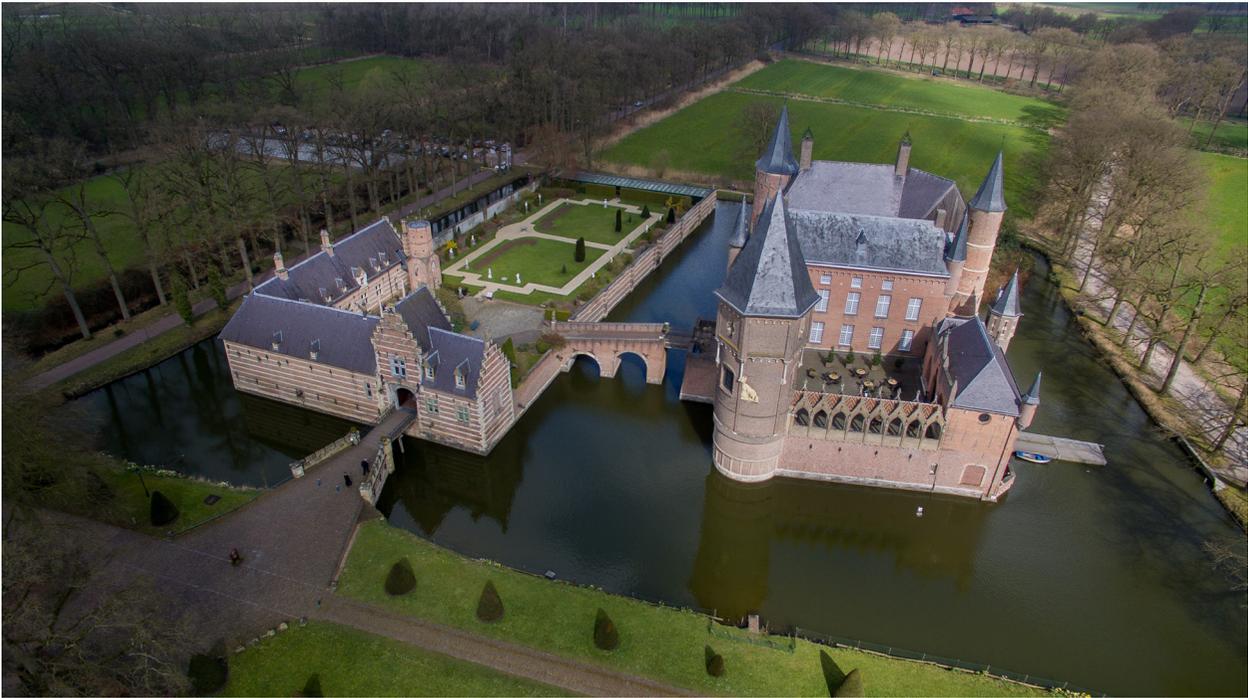
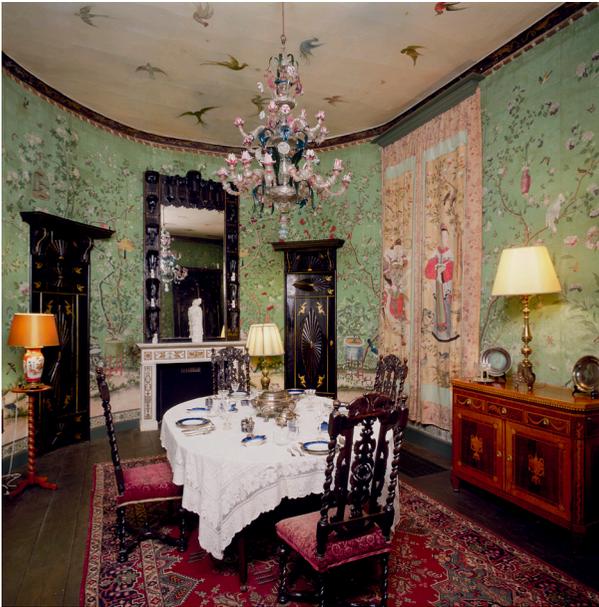
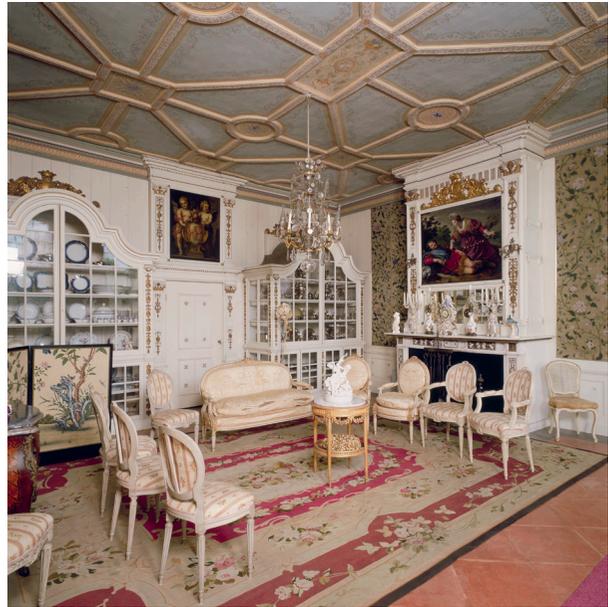
Fig. 1a-c
Overview (a), the Chinese room (b) and the White room (c) in Heeswijk Castle.

The main building of the castle has several so-called museum spaces. These are seen as the most valuable rooms in the castle and contain many important moveable objects of high cultural value. In figure 1 an aerial overview of the castle and two museum rooms are presented. In figure 5 the museum rooms are indicated by a colour in the floor plan of the first and second floor.

- the fully decorated Chinese room with original wall paper, furniture, silk curtains, Venetian glass lamp and painted ceiling (see also fig. 1);
- the Salon with important portrait paintings;
- the White room, with a unique asbestos floor (see also fig. 1);
- the Tin room uniquely decorated with wooden panelling and a large set of tin objects;
- the room where the last owner died with its unique gilt leather wall hangings.
