Preventive
Conservation
in Historic Houses
and Palace
Museums:
Assessment
Methodologies
and Applications

Conference Proceedings

Multi-View-Monitoring of Dimensional Changes of Wooden Panels Due to Changes in the Microclimate at Linderhof Palace

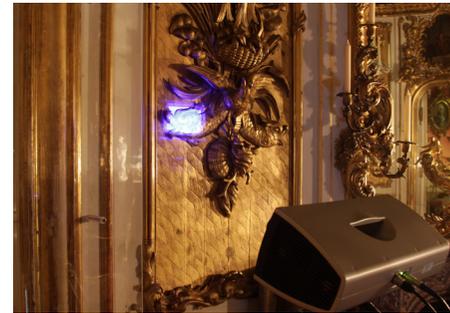
Fig. 3

Examination of a gilded wooden panel in the dining room using a structured light scanner. (Source: BSV)

To evaluate the changes caused by the new climate, it was necessary to document the regular seasonal changes of the historic furnishings in advance. This was carried out with a structured light scanner (SLS) (fig. 3). For the examination of the effects of short term fluctuations on already damaged surfaces, areas such as loosened parts of a gilded wooden panel were chosen. The investigation of these surfaces

The example described in this paper is a carved and gilded wooden panel dedicated to the art of fishing, situated in the dining room. Flaking and losses of gilt were found on the panel, especially on the left fish head (fig. 3). The joints have been partially repaired, which indicates large mechanical responses in the composite material (fig. 7). Before the installation of the ventilation system, the biggest and most frequent movement of the panel occurred between spring and autumn 2015 (fig. 8). During that period, various parts of the panel reacted differently. From March to July the left part of the surface warped to the front (fig. 8, left), whilst from July to October the right part warped to the back (fig. 8, right). The changes in T and RH over the course of 2015, as well as the times of data collection (marked in orange), are detailed in figure 9.

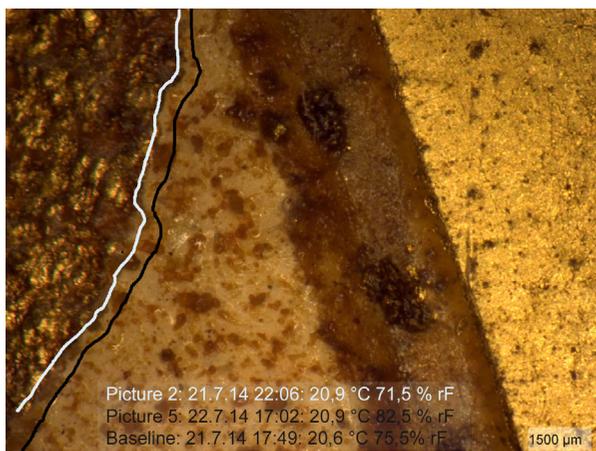
Fig. 5
 Left: visualization of climate induced movement by matching the single pictures and marking the contours of the gilt layer (source: BSV). Right: T and RH during measurement (July 21st-22nd, 2014) with the 3D-microscope (marked with black crosses).

For the examination of short-term fluctuations a single lens reflex camera (SLR) and a 3D-microscope were installed in front of the relevant area, focused on the damage, and left for the duration of the measurement campaign (fig. 5). The camera and microscope were programmed to take a picture every 20 minutes. Thus the impact of short term fluctuations could be examined micro- and macroscopically.

Unfortunately the analysis of the quantification of movement with the 3D-microscope didn't work on site as the motor used to focus on the object caused too many vibrations. Therefore, for both methods, an optical comparison was carried out by laying single images over each other using the graphical software Adobe Photoshop®. The change due to the mechanical response is made visible by tracing the contour of the flaking surface (fig. 5, left).

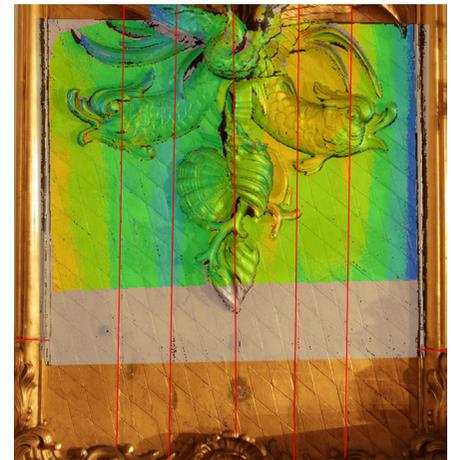
Fig. 7
Combined illustration of photography and assessment of the structured light scanner (March-October 2015). The red lines mark the joints.

The “1-shot-method” aims to minimise errors which can arise in the processing of the data. Two scans of the same area are taken at different times (last scan in the evening and first scan in the morning) without moving the measuring device. By this means it is possible to achieve a quantitative high resolution measure of the movement of the surface due to short-term climate fluctuations without the need to manually orient the scans via reference points (fig. 7).
