Preventive
Conservation
in Historic Houses
and Palace
Museums:
Assessment
Methodologies
and Applications

Conference of the National Museum of the Palace of Versailles (EPV), the Association of European Royal Residences (ARRE), and the Research Centre of the Palace of Versailles (CRCV)

Conference Proceedings

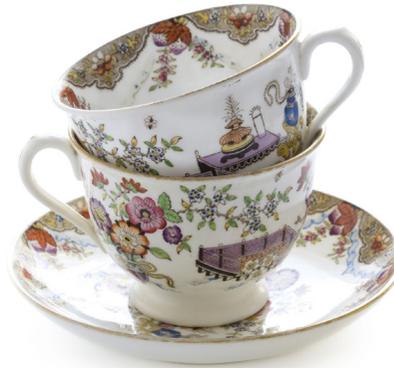
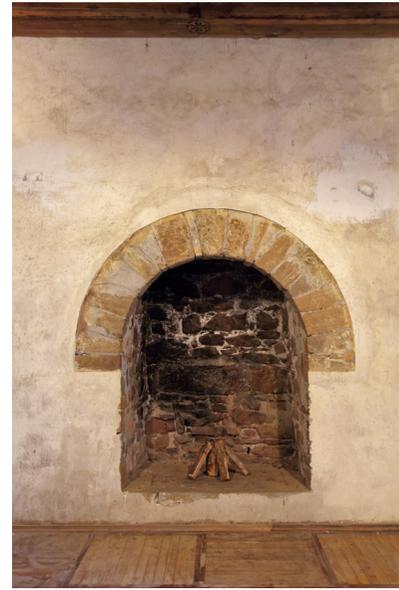
Fig. 1
Fragilities as different as delicate china and massive stone are within scope of historic house risk management.
(Source: 123rf.com)

To survive and retain authentic values over time, historic houses must guard against many diverse risks. Some of these are easy to compare and decide where to provide more protection. For example, guarding against visitor contact with a delicate china set will always be judged more important than guarding against visitor contact with a fixed fireplace mantel (fig. 1). Given similar levels of care

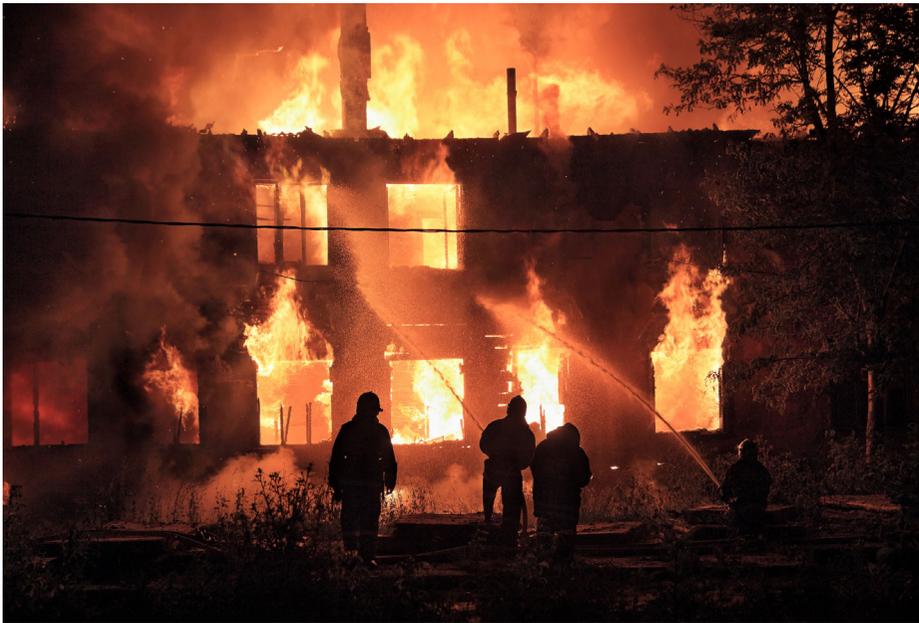
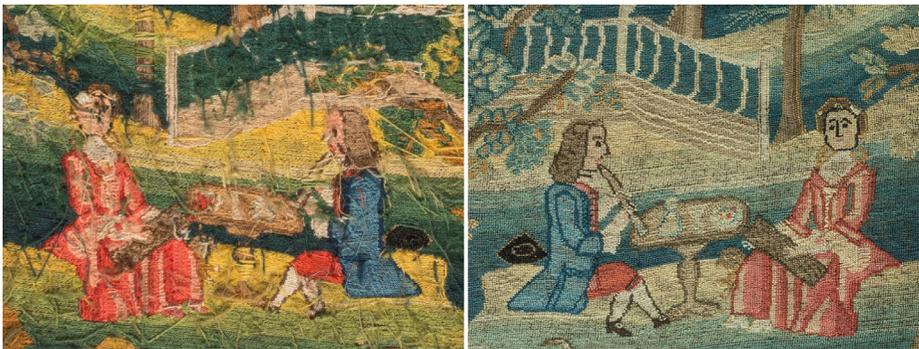
Fig. 2
Risks as diverse as total destruction by fire and fading by light need to be considered and evaluated. (Source: 1223rf.com b). Mary Perrin (1737-1815), Roxbury, Massachusetts, 1750, wool, silk and metallic thread on linen. Museum purchase with funds provided by the Henry Francis du Pont Collectors Circle 2016.66. Left: back showing vibrant colors. Right: front, faded by light, as seen on display. Courtesy Winterthur.

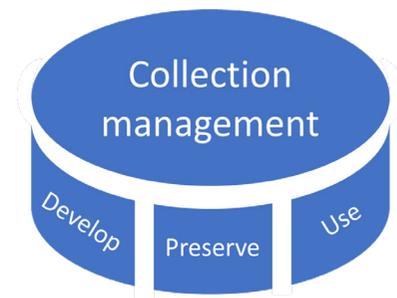
Fig. 4
The heritage management system includes three major sub-systems. (© Protect Heritage Corp.)

Fig. 5
a) Magnitudes of risks to CMN collections by generic risks in 1998.
b) Magnitudes of risks to CMN collections by generic risks in 1998 after filtering to retain only risk controlled by facility management.
c) Magnitudes of risks to CMN collections by generic risks in 2003 after filtering to retain only risk controlled by facility management.
d) Magnitudes of risks to CMN collections by generic risks in 2008 after filtering to retain only risk controlled by facility management.
To enable clarity in scaling, risks specific to fluid preserved collections have been excluded. Only relative risk magnitudes are shown as those convey all important meaning and guard confidentiality. (© Protect Heritage Corp.)

Figure 5a shows 1998 magnitudes of risks (magnitude expressed as expected loss in value over the next 100 years) to collections by generic risk. That is of limited use to facility management as it includes many risks that are completely outside of that departments control or even influence. Figure 5b shows the 1998 generic risk magnitude distribution after filtering to depict only how much of each generic risk facility management is able to control or influence. The remaining (filtered out) risk magnitudes would be controlled or influenced by other groups such as conservation, registration, etc. The solid line toward the top of the graph depicts the running total risk magnitude across the set of generic risks. It serves as a reference when depicting reductions in overall risk magnitude.

Figure 5c depicts the facility management-related risk magnitude distribution five years later (2003) after facility management was able to address the share of physical force issues it could mitigate. During those years both facilities management and conservation science worked on defining options for – and evaluating risks, costs, and benefits of – reducing collection light exposures in storage. Figure 5d shows the facility management-related risk distribution in 2008 after

a strategy for reducing light damage was implemented. It is evident that facility management was able to focus effort and resources to achieve a substantial reduction in overall risk to collections. Arguably, the CMN facility management group did outstanding work in reducing the amount of risk they could influence.

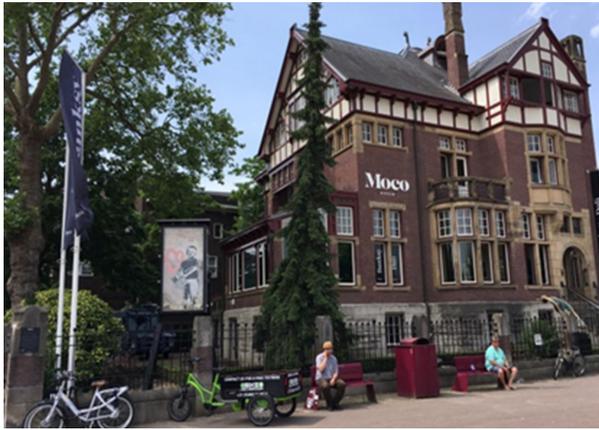
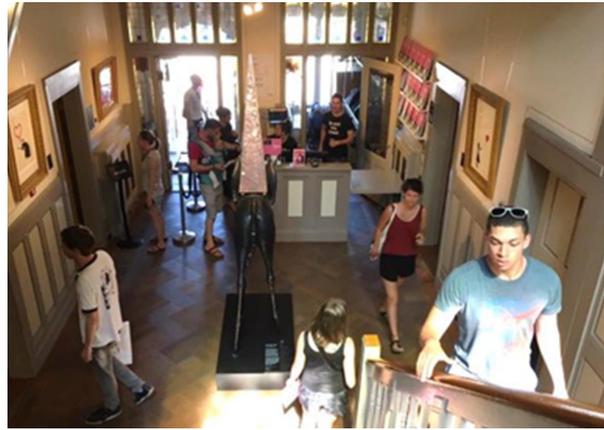
Deekcollectie	GW	FK	Water	Brand	C&V	Ongedier	Veront	LUV	onj RV	onjT	Disso
Werk op papier of karton	10,7										
Verf op doek	12,6										
Verf op hout	7,8										
Metaal met/zonder verf	3,7										
Steen en ops met/zonder verf	8,0										
Verf op kunststof	0,8										
Werk op perkament of leer	0,9										
Varia	5,5										
Voeren 1000 m2 = 100 st	13,7										
Wanden	12,9										
Plafonds 1000 m2 = 100 st	2,7										
Glas-ramen	2,4										
Fixtures	18,3

Fig. 9 Application of combined methods with students at MOCO, Amsterdam.

In 2017, a group of 15 Master students from the University of Amsterdam applied the combined approach at the Modern Contemporary Museum (MOCO) in Amsterdam during a 1-week risk management module (fig. 9). The museum displays its art collection in a listed

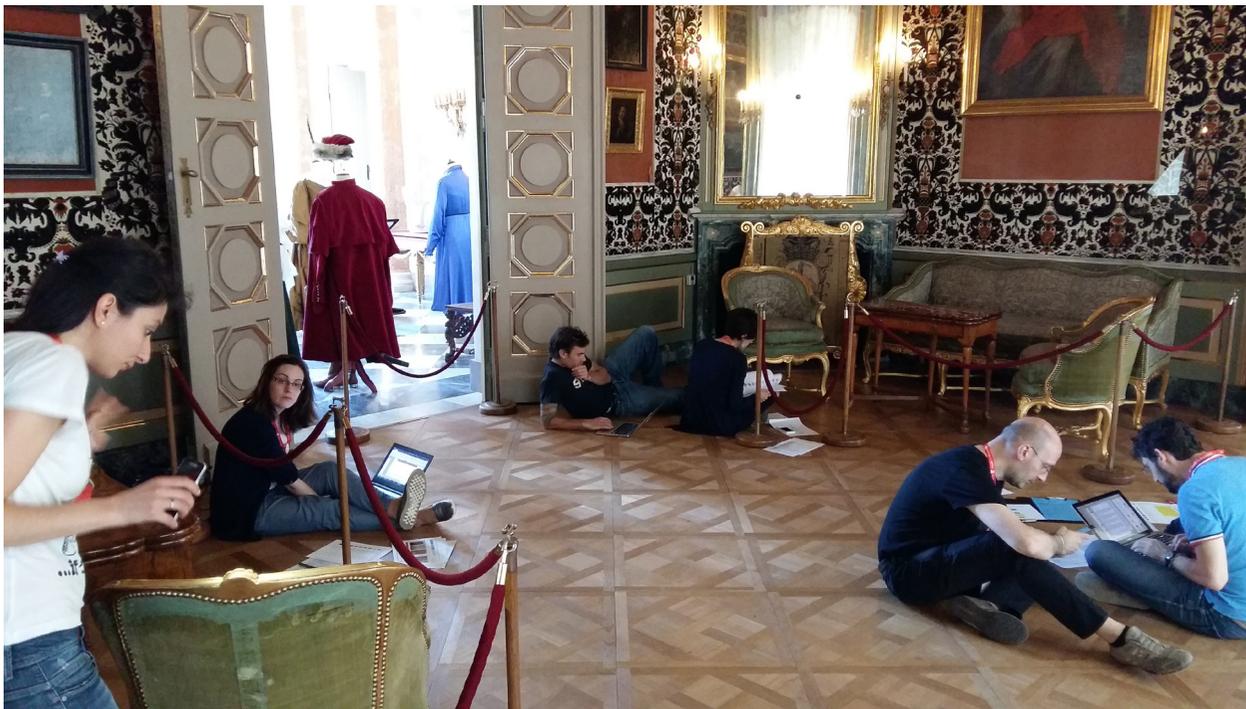
Fig. 1

Assessment of the Collections in the Dutch Cabinet at the Wilanów Palace in June 2016. (© EPICO team)

The preparation of a reference glossary of deterioration indicators requires a considerable effort to establish comparable reports: all the objects from the assessed rooms using the methods, were analysed based on sixteen indicators we developed in order to measure the observed damage. The glossary was all the more valuable as the teams made up of museum professionals from different specialties and from three different countries (fig. 1).

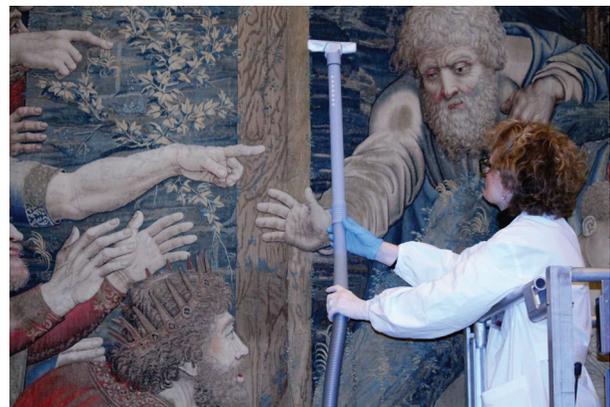
Fig. 8
Intervention methodology: detail. (© Governatorato SCV – Direzione dei Musei)

After ideally subdividing the surface of the tapestry into areas of 1 or 1.5 square meters, the intervention method requires the frontal aspiration of the artefact, indirectly, through the interposition of a filter on the nozzle of a low power vacuum cleaner, for about 10-15 minutes (fig. 8).

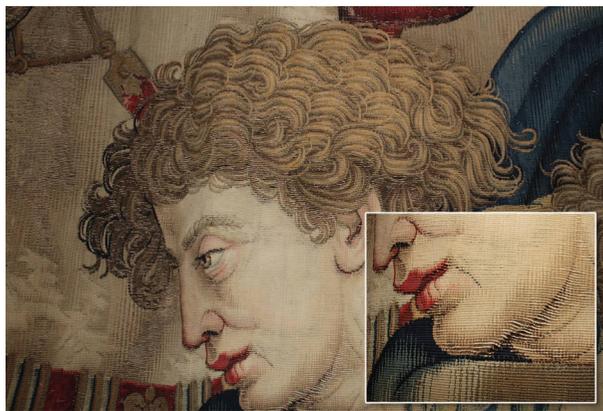
Fig. 12
Conservation state documentation: detail
of a weak area. (© Governatorato SCV –
Direzione dei Musei)

unstitched supports, loose warps, localisation of worn out areas, lacunae, fading (fig. 12).

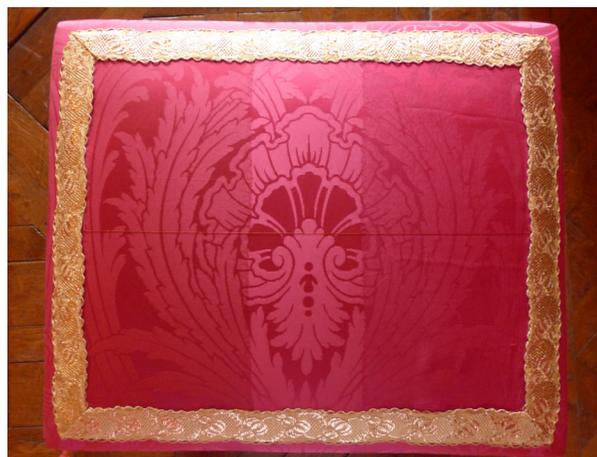
Fig. 5
Tests for the protection of fragile fabrics with a crepeline or a tulle cover (© Vrinat Consortium).

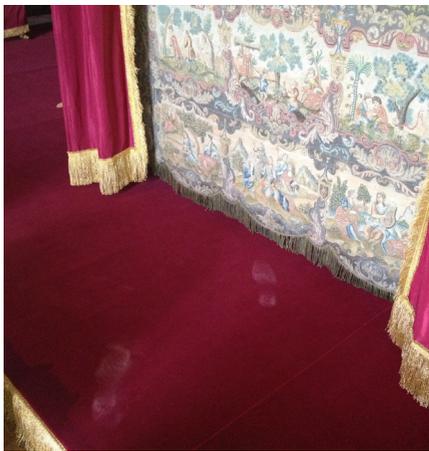
Fig. 7
Footprints on the Mercure Salon platform (© Vrinat Consortium).

of the floor polisher...) (fig. 7). The delicateness of the textiles also determines the frequency of the passages. As an example, the most dusted areas are (unsurprisingly) the Hall of Mirrors, the Grand Couvert, the King's State Apartment... Conversely, other spaces are only covered by an annual passage like the Midi and North Attics which are little open to the public so less dusty, the same applies to interventions requiring scaffolding such as the imperial ones,

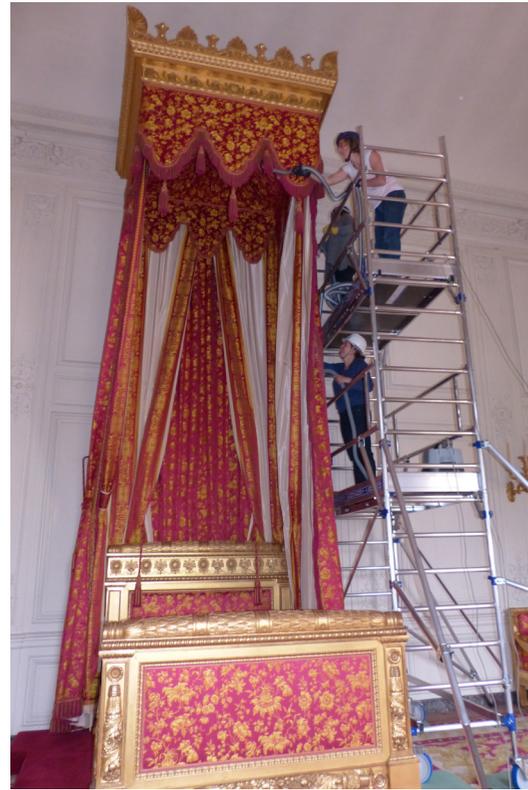
Fig. 9
The dusting of beds and
imperials with scaffolding
(© Vrinat Consortium).

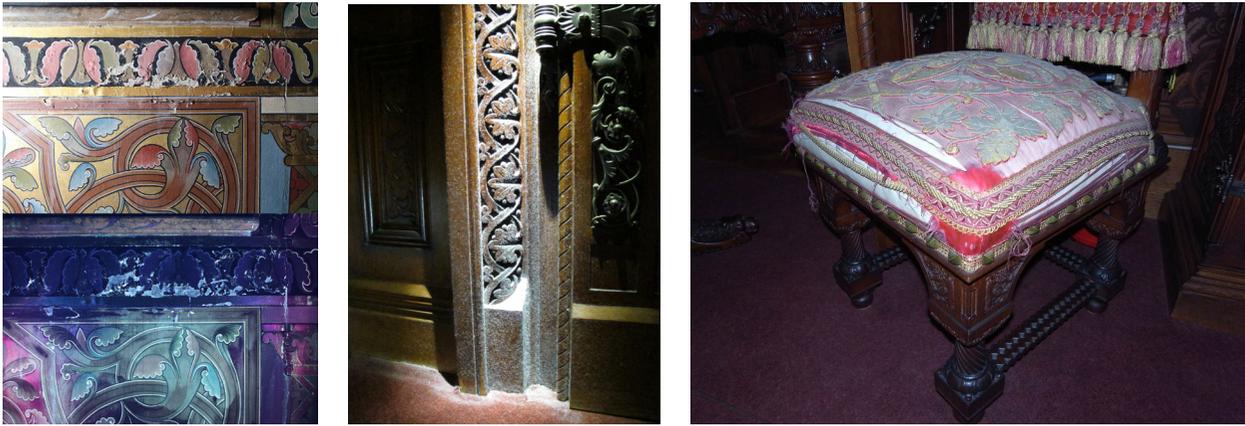
obvious on the first sight; following detailed surveying and mapping of the damages especially on the wall paintings identified not only the existing damages but also not apparent local touch ups notably on the outer walls (fig. 2). The big amount of damages and losses of the paint layer shows that the condensation is really a high risk for the wall paintings.

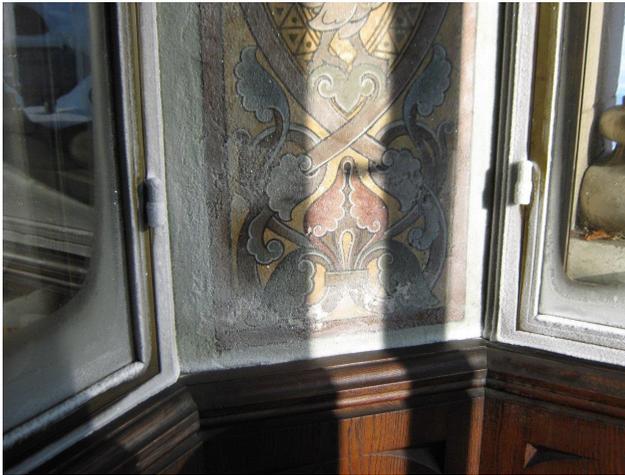
Fig. 7
Neuschwanstein Castle,
Living Room, northern
oriel. Ice formation due to
condensation problems on
the painted surface of the
outer wall. (© Staatliches
Bauamt Kempten, Ralf
Gehrke)

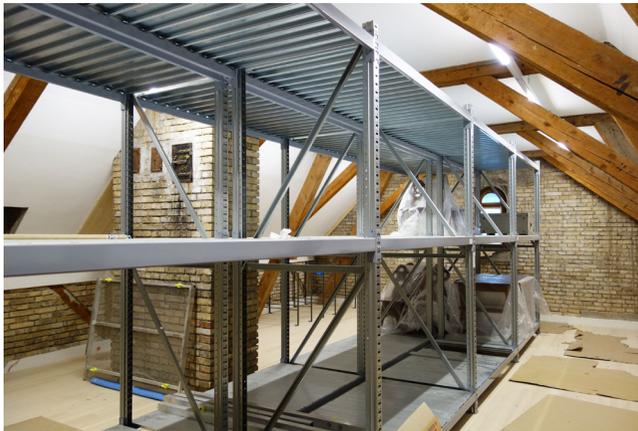
Fig. 10
Neuschwanstein Castle,
Ritterhaus, new storage.
Unfinished rooms are
turned to low-tech storages.
Conservation heating and
dehumidification
will keep the RH under
65%. (© Bayerische
Schlösserverwaltung, Heiko
Oehme)

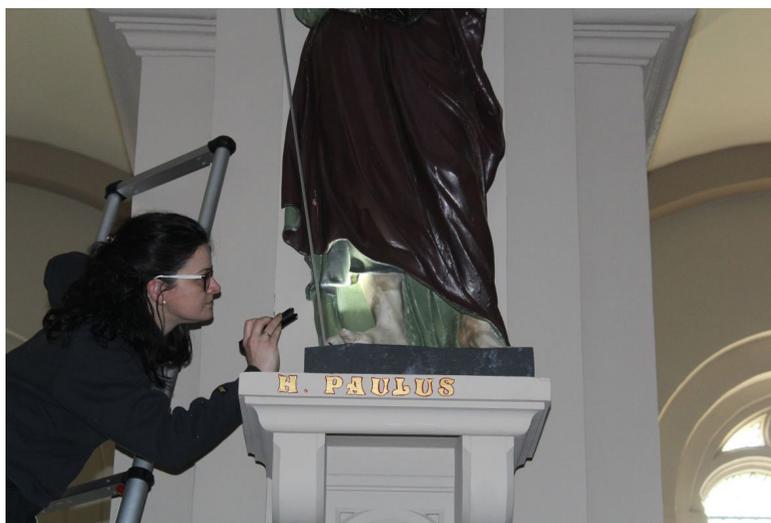
Fig. 1
Removing mould on a polychrome thirteenth-century shrine.

As I already quoted, not only words but action, with emergency repairs it is possible to avoid an expensive and invasive restoration (fig. 1). For the "big" restoration jobs, ex. a whole interior, we refer to professional restorers or architects.

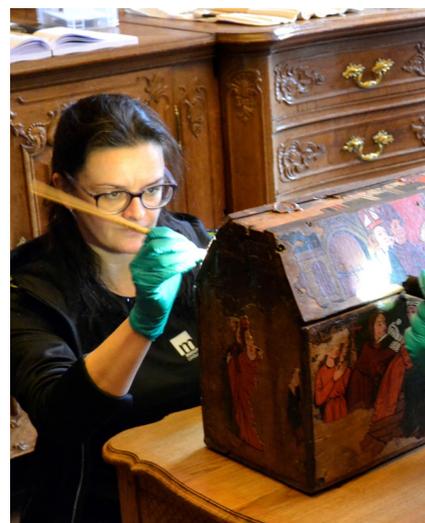
Fig. 2
Inspection of a polychrome nineteenth-century sculpture.

On demand by the owner we perform an inspection/survey on the interiors and the objects (fig. 2). This systematic control happens on a regular basis, at least every four years, to examine their state of preservation. The detailed survey/report we impose, includes the condition of the interior, of the objects and the damages. It is a manual with recommendations for better preservation and/or maintenance and conservation. Included we give the owners onderhoudsfiches: maintenance cards who are a particular guideline for the inspected interior or object. I have some examples of such reports as well as some maintenance cards.

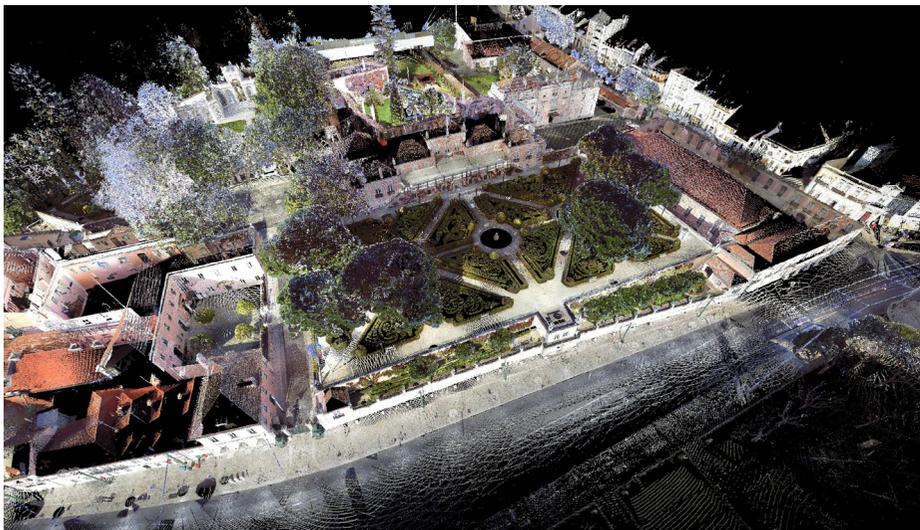
Fig. 1
Point Clouds: 3D laser scan and digital photogrammetry (381.5 M points), ArcHC_3D Research Group, FA, Univ. Lisbon.

A 3D scan made in 2011 (fig. 1) was used to manipulate the entire complex as if it was a model, allowing to see it from several different perspectives, including 2D elevations and finding problems that were invisible from the ground. Some distortions found in the exterior walls of the main rooms were noticed at the time and became under surveillance. After 7 years, another 3D scan was done to the same problematic areas to monitor its evolution.

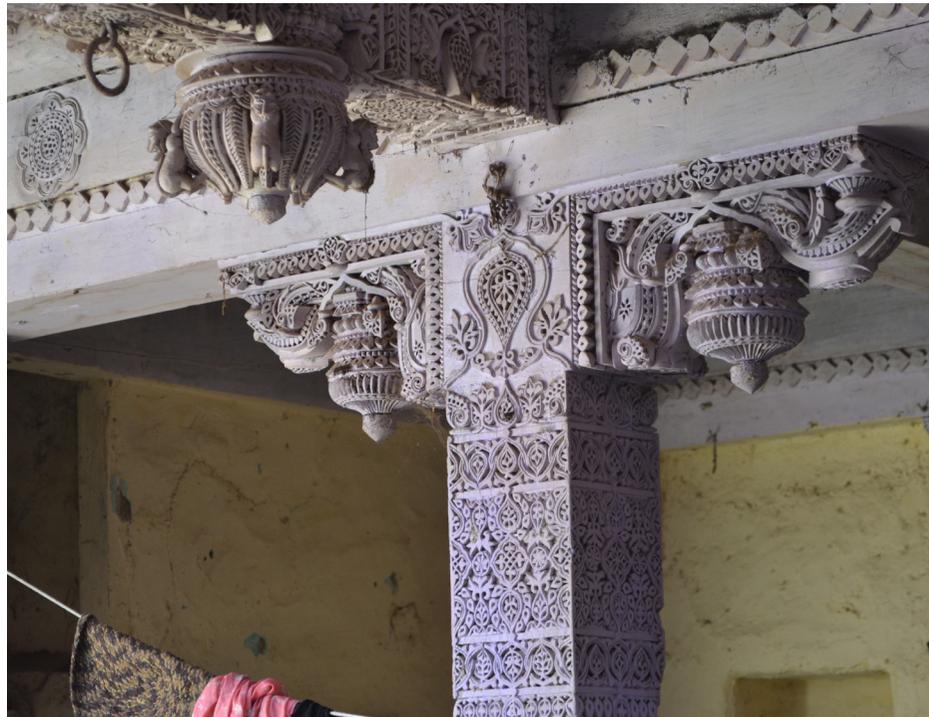
Fig. 1

Photo showing a variety of materials used in constructing the external envelope. (Source: author)

The wadas in Paithan vary from the typical wadas of Maharashtra in their architecture as they are asymmetric and ornate (fig. 1 and 2).

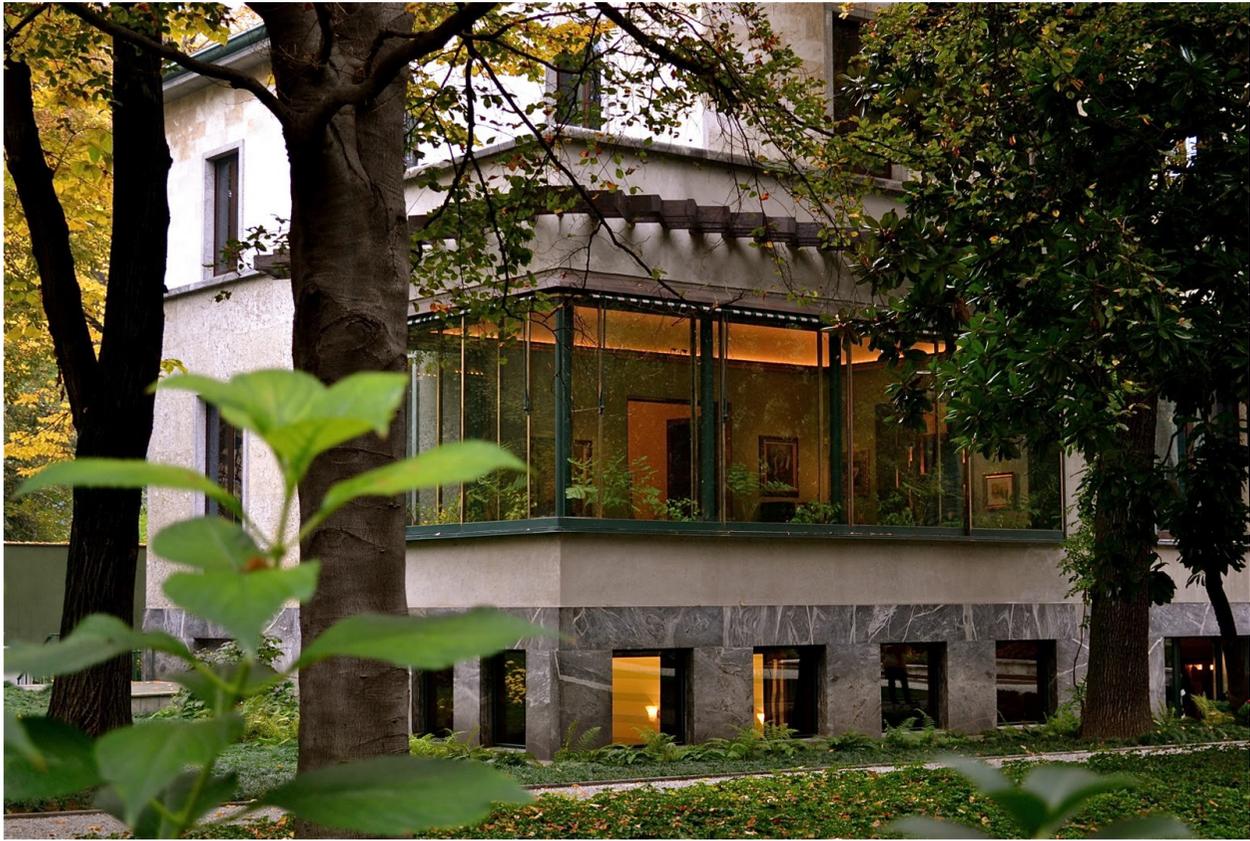
Fig. 1
The conservatory of Villa Necchi Campiglio, an example of a glazed area where anti-UV films have been applied. (© Archivio FAI)

resistance than the rest of the building, naturally implying more radiation. As far as the reduction of light is concerned, we have therefore applied an anti-ultraviolet film on the Villa's historical window glasses, with the use of technical curtains or double-curtains.

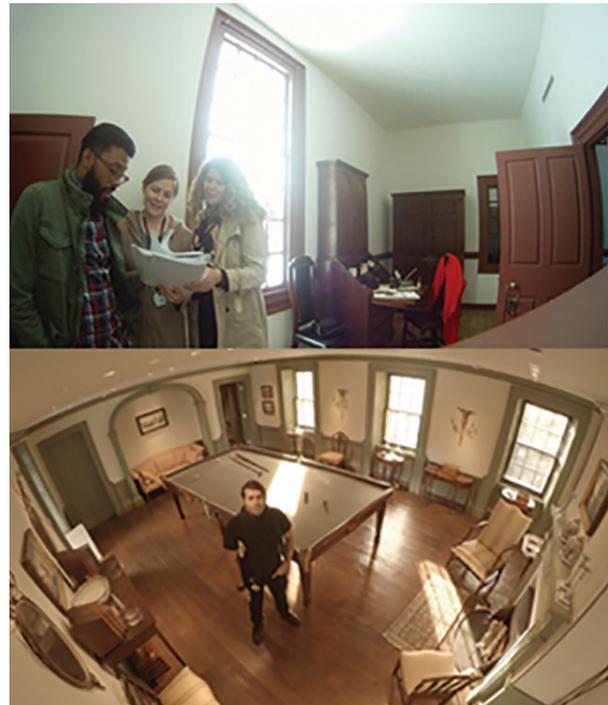
Fig. 1
Wide-angle GoPro™ images showing Wetherburn's Porch Room with E. Wroczynski, D. Brooks, and A. Blake-Howland and the Billiard Room with N. Kaplan.

Image metadata is being analysed with the command line program Exiftool. Of interest specifically is the “light value,” which the cameras use to determine automatic functions like shutter speed and is comparable to lux averaged over the camera’s field of view. As a year of data is collected, protocol is being developed for processing images into a compressed, stacked view to help identify patterns of exposure. Settings and workflow are described in table 1. Final conclusions will be compared to architectural predictive light modelling.¹

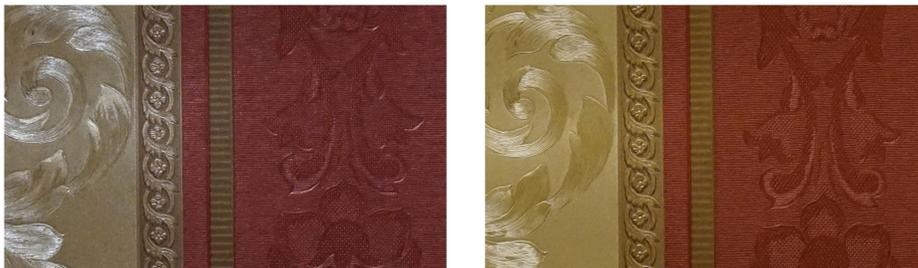
Fig. 1
Same wallpaper; different
lightsources.

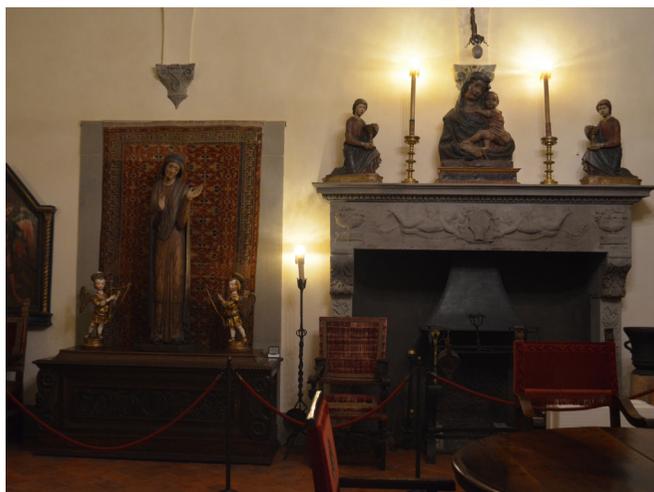
Fig. 1
Sala da Pranzo –
Monitoring RH and
temperature. (Source:
Katherine Parks, Villa La
Pietra, NYU Florence)

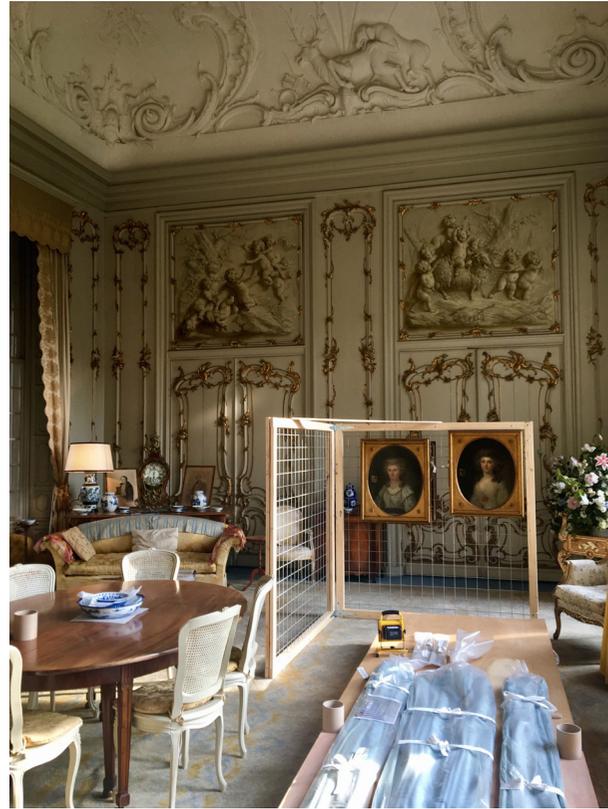
Fig 2

The Grand Reception Hall with temporary storage for curtains and paintings with regard to the building works. (© C. Groeninx van Zoelen)

– Completion of global risk analysis, basic list of objects per room, damage assessments, advices. Establishment of protective measurements, including the development of a temporary storage for textiles and paintings (fig. 2).

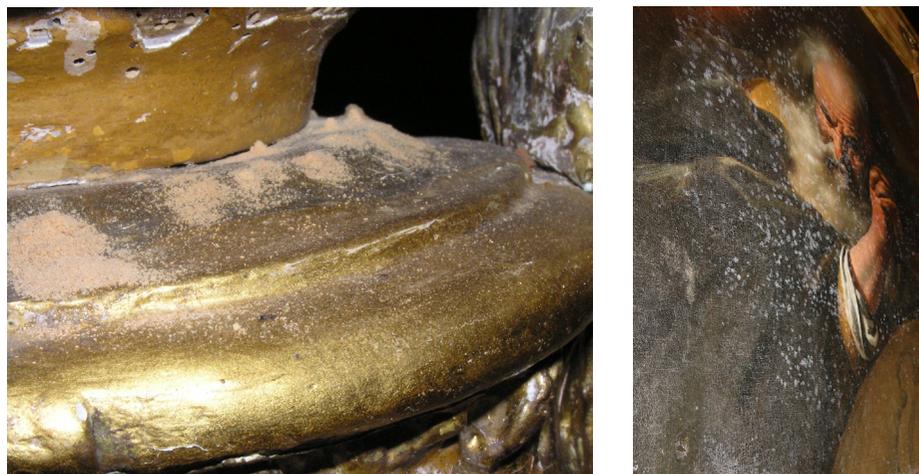
Fig. 3

Left: frass from *anobium punctatum* emergences on a table leg in a piece of Baroque furniture from Knole. Right: mould growth on surface of a painting. (© National Trust)

As such, the collections have become accustomed to a high relative humidity (RH) environment where the annual RH typically ranges 55 to 90% with an annual average of about 70%. Research in the last two decades has greatly advanced our understanding of the climatic response of hygroscopic materials and it is no longer assumed that controlling to a museum RH standard, such as $55\pm 5\%$ is the correct approach for the care of such a collection. Modern preventive conservation thinking takes far greater account of the historic climate of the objects, and the concept of long-term acclimatization is at the heart of the European Standard EN15757, *Specifications for Temperature and Relative Humidity to Limit Climate-Induced Mechanical Damage in Organic Hygroscopic Materials*. Applying the EN15757 method to determine safe climate for mechanical damage to the conditions at Knole, suggests, a winter RH range of 75-90% (fig. 2). Indeed, the Knole collection appears to be stable mechanically at the current high RH conditions. However the high RH also promotes wood-boring insect attack, which is evident on much of the furniture and regular and persistent mould growth on textiles and paintings (fig. 3).

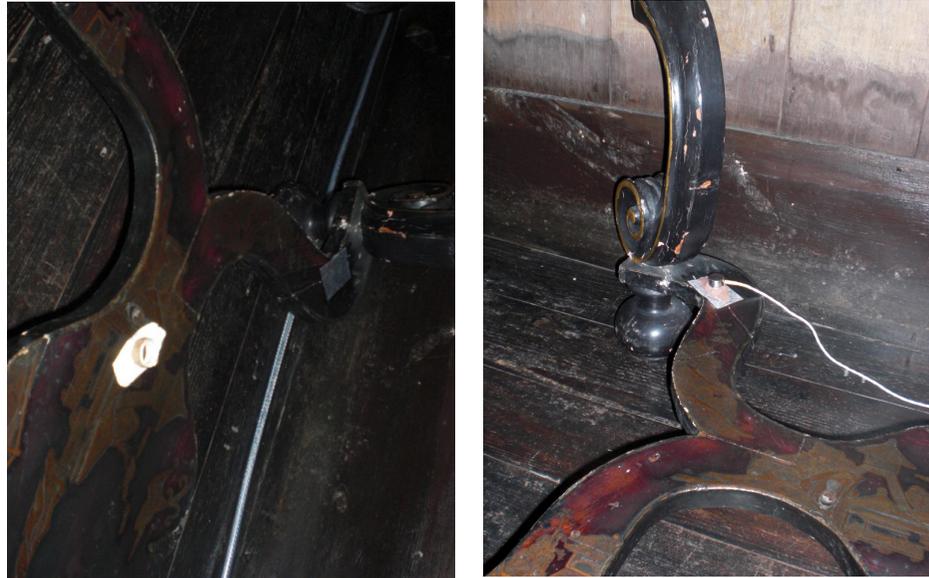
Fig. 4

Attachment of AE sensor to the Jensen Suite table, March 2016. Left: tissue pasted to bracing bar of Jensen table with sensor mount ready for attachment. Right: completed sensor mount with cylindrical steel sensor in the acrylic moulding (© National Trust).

need to be physically attached to the objects in order to detect sounds correctly. A reversible method of attachment was devised in consultation with, and applied in March 2016 by, the Trust's specialist furniture conservation adviser John Hartley. Japanese tissue was first glued to the object surface using starch paste and then the acrylic AE sensor mount was adhered to the tissue using Paraloid B72 adhesive (fig. 4). In the case of the Gole table the AE sensor, located between table leg and support, was wedged in place using plastazote.

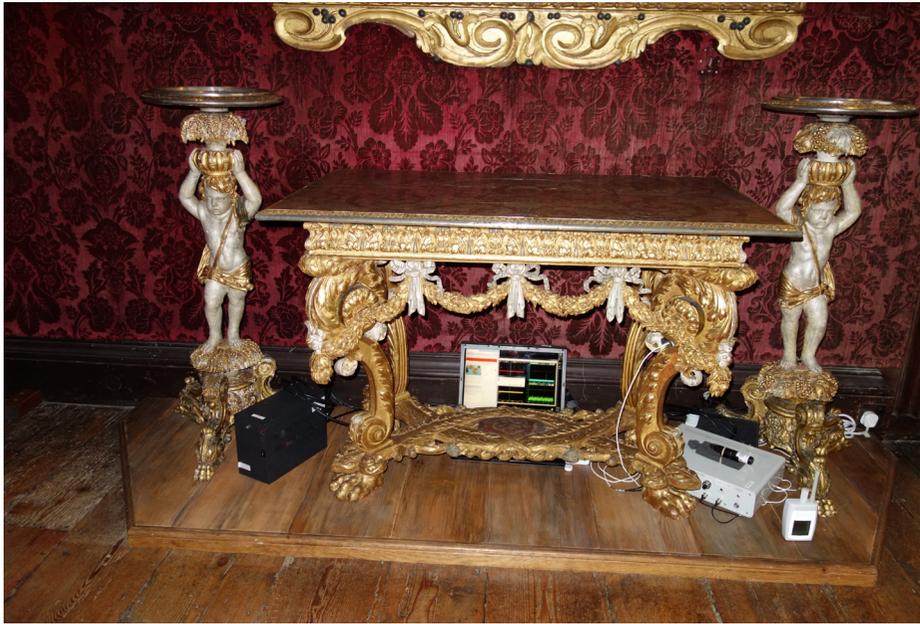
Fig. 5
Gole Suite table and torchère in Cartoon Gallery with AE monitoring equipment. AE sensors connect to the amplifier (right), which is linked by the PCI interface (left) to the laptop (rear centre). Hanwell T and RH sensor temporarily located in the foreground. (© National Trust)

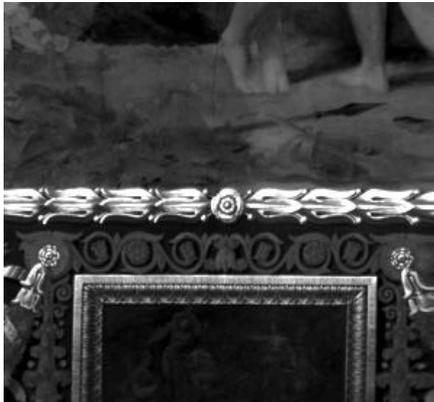
Fig. 2
Visualisation of the analysed area in the bands corresponding to wavelengths 1200 nm.

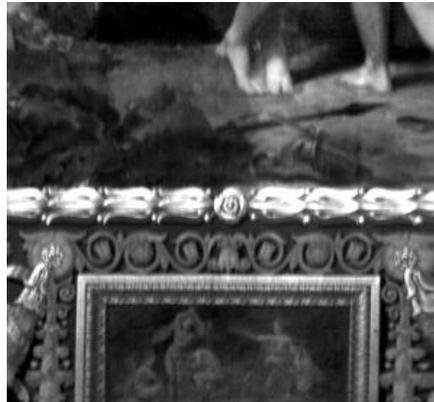
Fig. 3
Visualisation of the analysed zone in the bands corresponding to the wavelengths 2000 nm.
