KEY FIGURES: EPICO AT THE PALACE OF MAINTENON, FRANCE

APRIL 2019

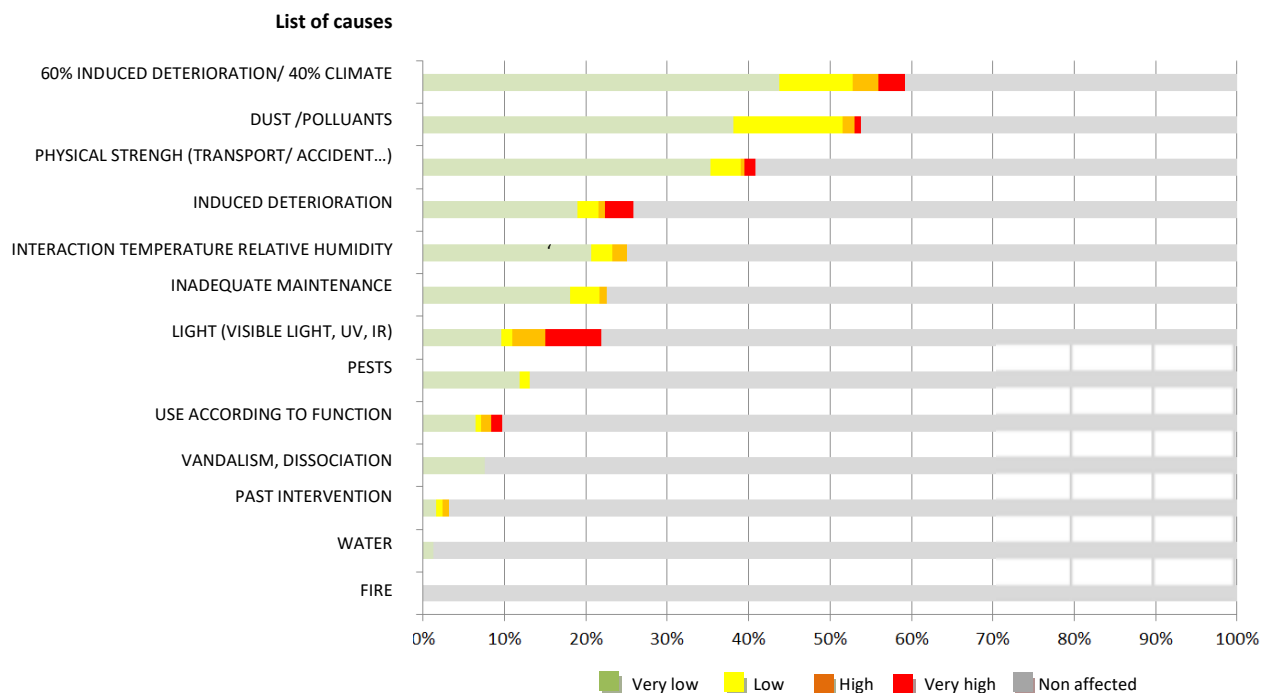
RANKING: alteration cause impact (objects affected by causes + scale of damage):

-1500 Total number of inventoried work → 93 objects in the EPICO sample
(confidence level = 95%; margin of error 10%)
-23 selected Rooms → 14 Zones
-548 damage causes founded
-3 major causes: 60% Inherent degradation-40% climate, Dust-Polluants,
Physical forces

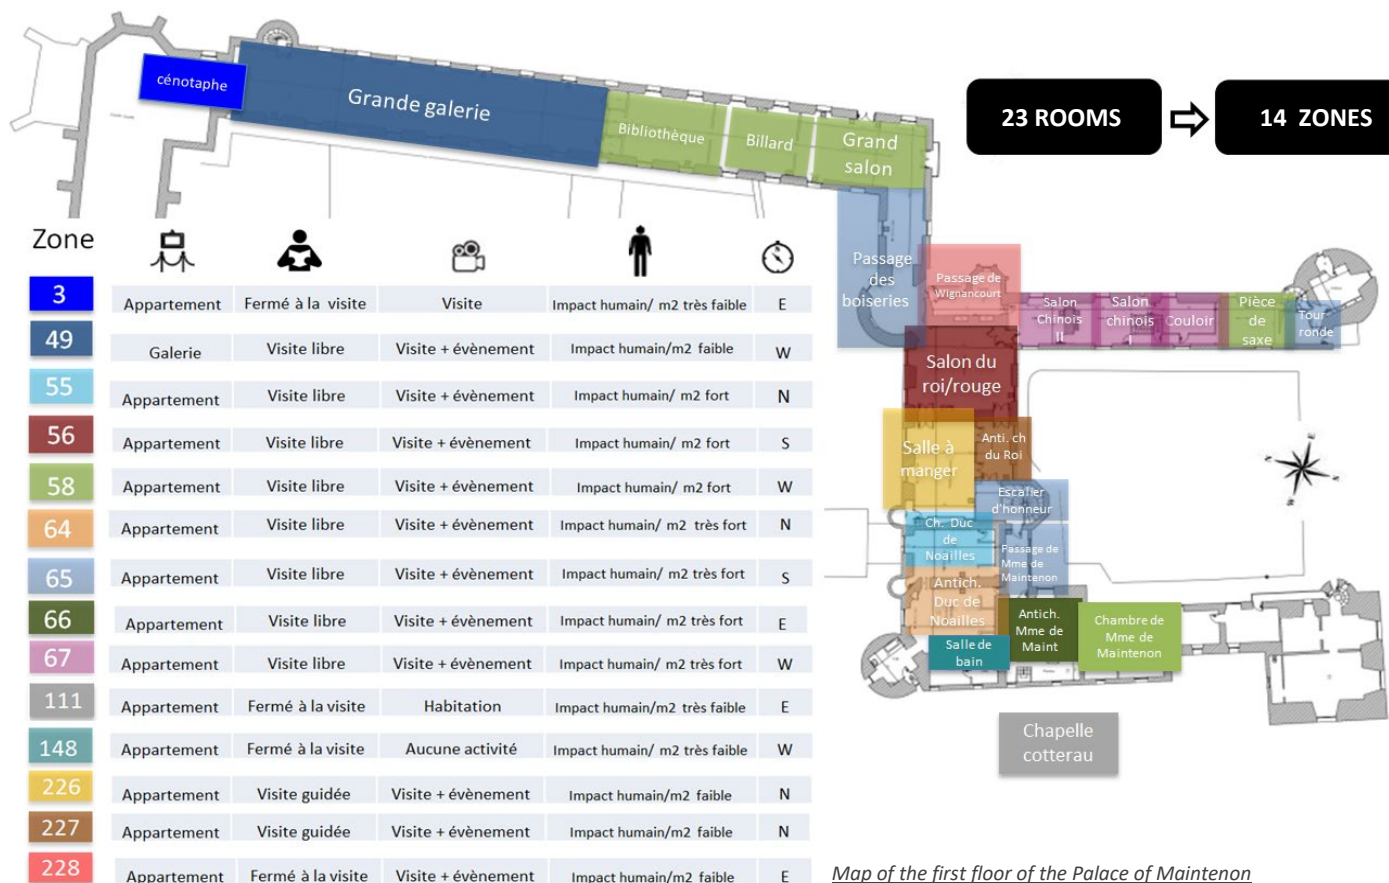
Map of the first floor of the Palace of Maintenon

Zoning makes it possible to group rooms with similar characteristics (museography, type of visit, activities (film shoots events...), human impact and orientation) with have similar impact on the collection.

*On the map we have the name of the room and the color of the zone
