Preventive
Conservation
in Historic Houses
and Palace
Museums:
Assessment
Methodologies
and Applications

Conference Proceedings

Royal Palace of Caserta, Preventive Conservation of Stone Facings of Huge Facades

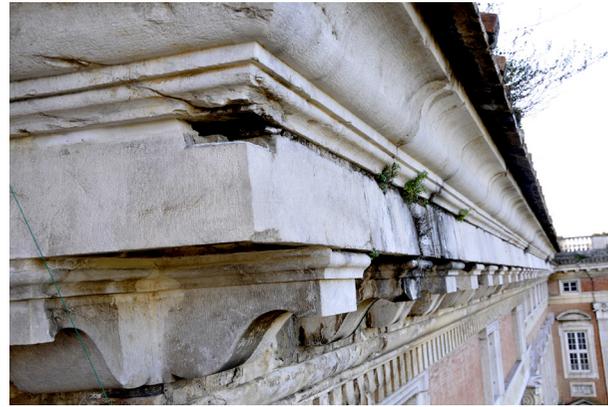
Fig. 1
Before restoration:
degradation of stone
mouldings caused by rain
water.

Diagnostic studies and tests performed during restoration work revealed that detachments were generally due to the infiltration of water into the limestone.

On the top of the outer wall there is a gutter built into the masonry, which collects rainwater from the roof. The growth of weeds, or even shrubs, on top of the outer walls had obstructed the gutter thus blocking the drainage system and has caused the penetration of rainwater into the joints between the blocks and the core of the stone. The water absorbed by the stone froze into ice in winter, thus damaging the limestone, consuming the calcite along the lines of the geological veins and causing both large and small fragments of masonry to break off and fall to the ground. In fact, most cracks were concentrated in the big projecting cornice immediately below the gutter.
